**HOMEBUYERS  
INSPECTIONS INC.**

Printed Wednesday, March 31, 2010

Inspected 3/31/10 10:00 AM

INSPECTION  
INFORMATION /  
CONDITIONS

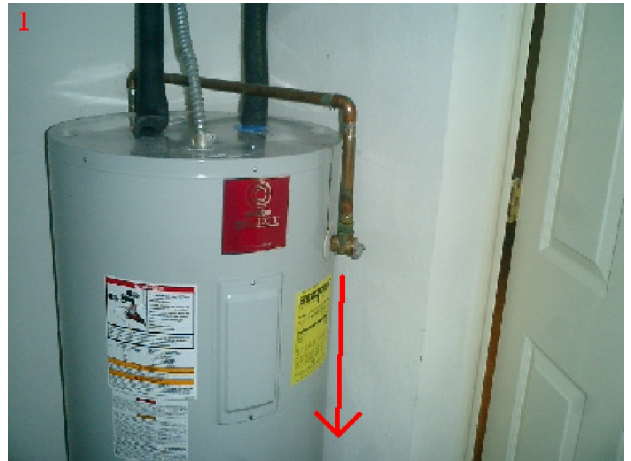
**Conditions** **Water Heater 1 Type / Size / Location - Electric, 50 gal, Closet**

Master bedroom closet.

In a pan with a drain.

Improvised installation - TPR (temperature & pressure relief) valve - vented up. Safety!!!

Have further evaluated & corrected by a qualified plumbing contractor.

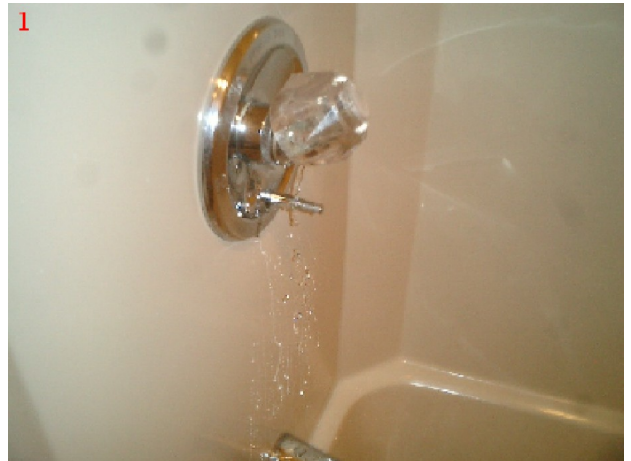
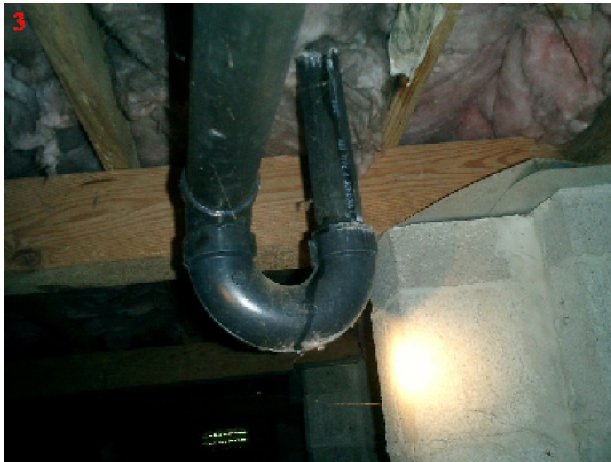
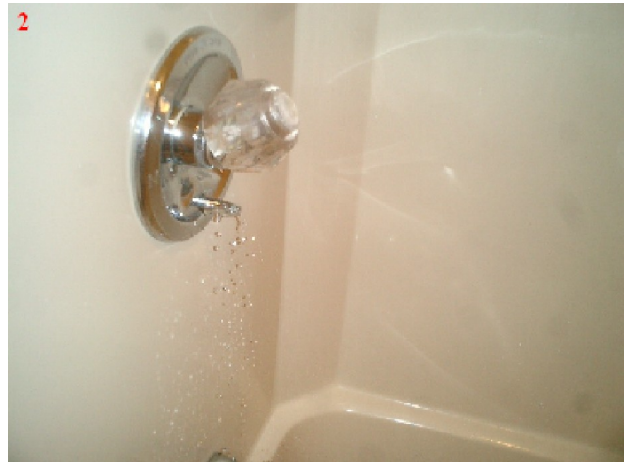
### **Conditions** Hall Bath Bathtub - Tub with shower

Grout between tub and tile.

Leak at shower diverter - repair.

Leak at single handle faucet.

Toe stopper missing - replace.

Leak at drain in crawl.

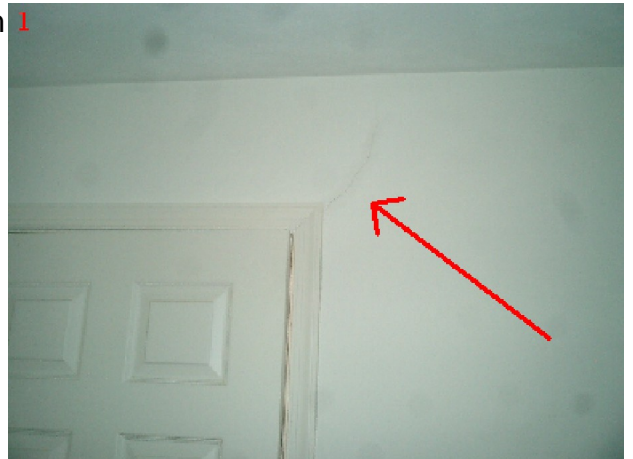
#### Walls - Wood Frame

Settlement crack over master bedroom door. Patch <sup>1</sup> & monitor.

Settlement crack living room / entry. Patch & monitor.

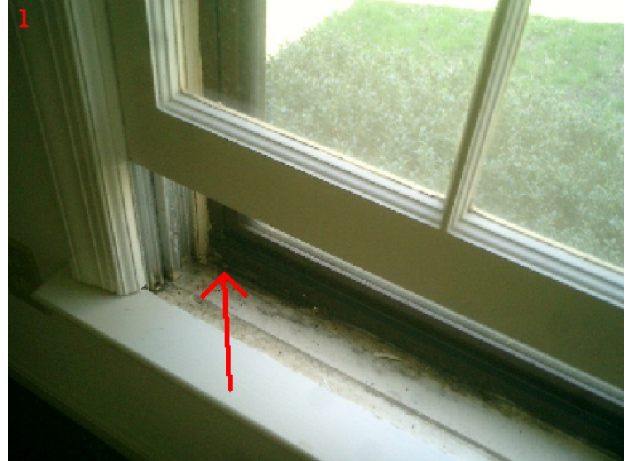
#### Maintenance Windows - Sample Number Operated, Window treatments present.

Original wood single pane double hung windows with storm windows.  
Paint deteriorated at window wells at FROG and front bedroom windows.  
Scrape, prime & paint.  
Close storm windows when windows are closed.  
Keep weep holes clear of debris.  
Some windows pinned closed.

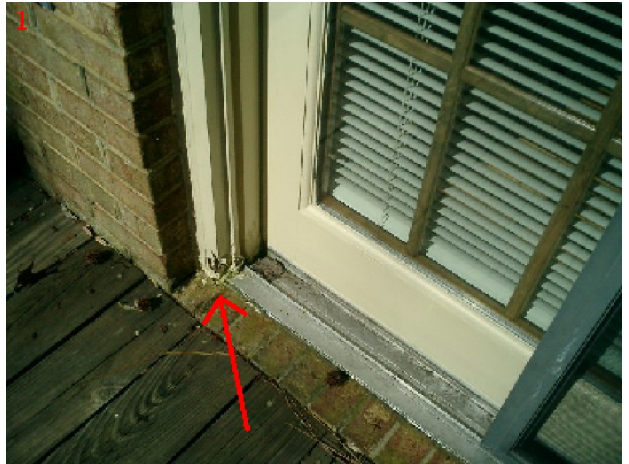
### **Conditions** Entry Doors - Wood, Storm\Screen

Left French door - Foot of frame moisture damaged.

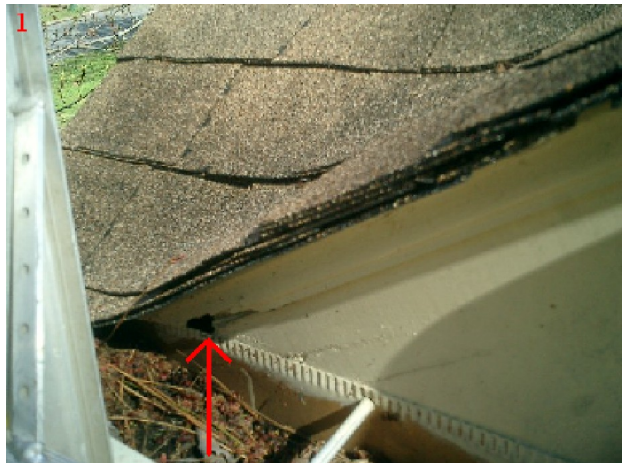
### **Maintenance** Trim / Soffit / Fascia - Wood

Keep caulked and painted on schedule.  
Seal hole at front right eaves.

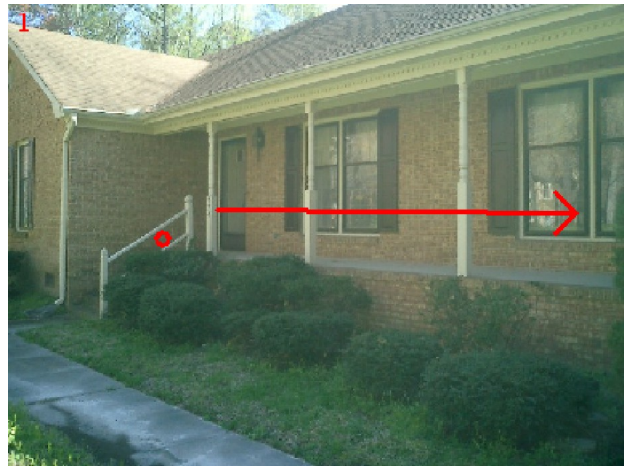
### **Maintenance** Porches - Brick, Concrete

Slab cracked - seal.

No guard railing at front porch & open hand rail at steps.

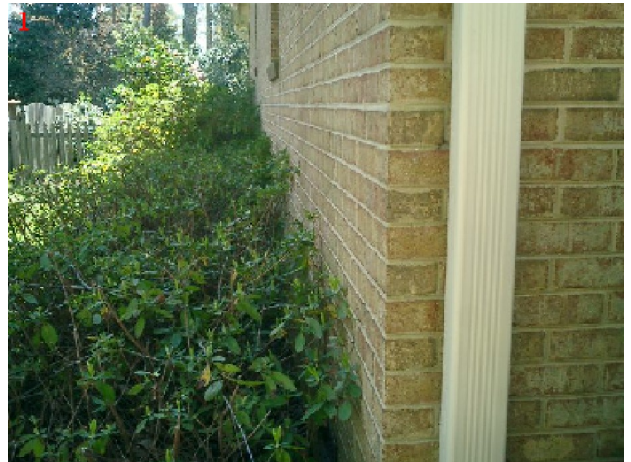
### **Vegetation - -**

Cut back bushes in contact with house at left side.

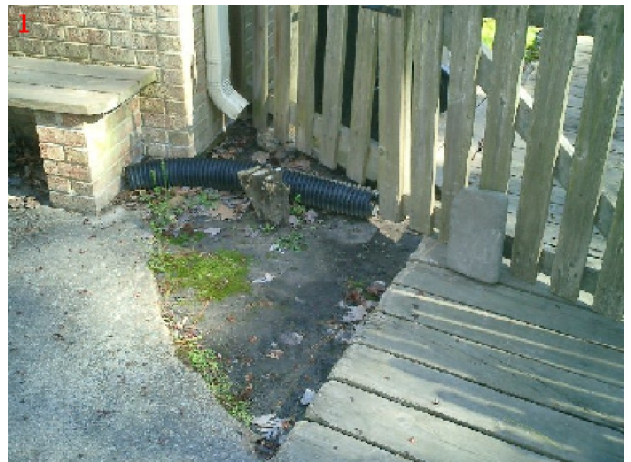
### **Conditions** Grading & Drainage - Neutral

Wet lot.

Water pooling under deck.

water pooling at downspouts.

Control roof drainage, re grade and monitor.

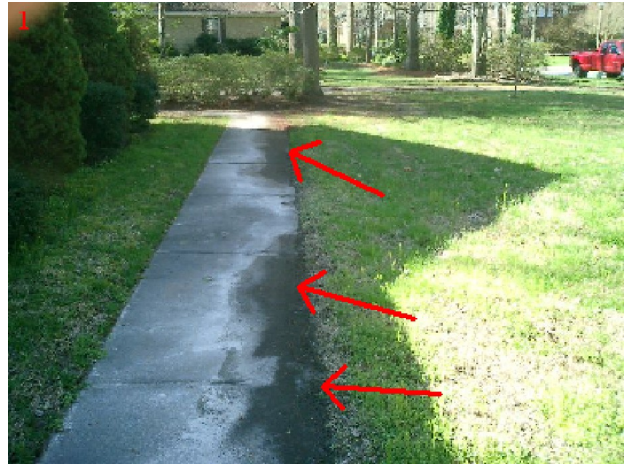
### **Walkways - Concrete, Wood**

Evidence of pooling water at front side walk.  
Wood walk way dry, brittle, splitting at nails,  
warped, protruding nails etc.

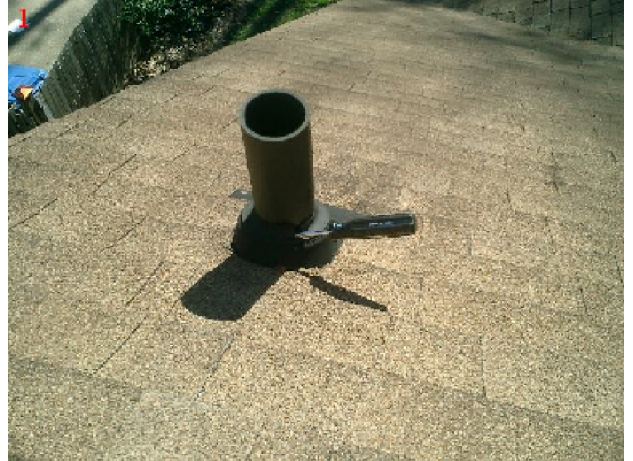
#### Conditions Roof Penetrations - -

Left rear 4" plumbing vent collar split - replace.

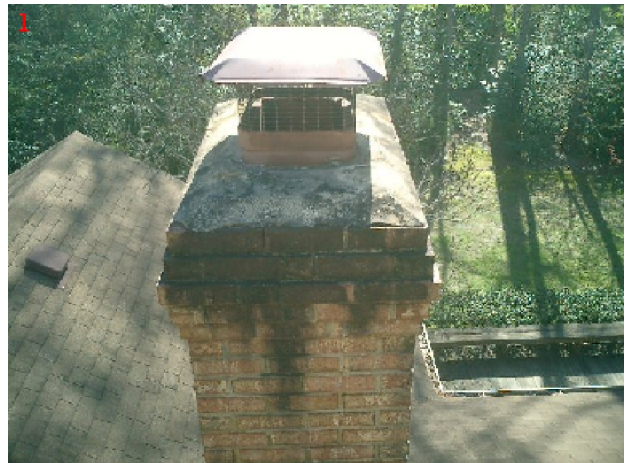
#### Conditions Chimneys & Flues - Brick

External inspection only. The condition of the flue can not be determined and is beyond the scope of this inspection.

Mortar crown cracked.

Metal cap rusted.

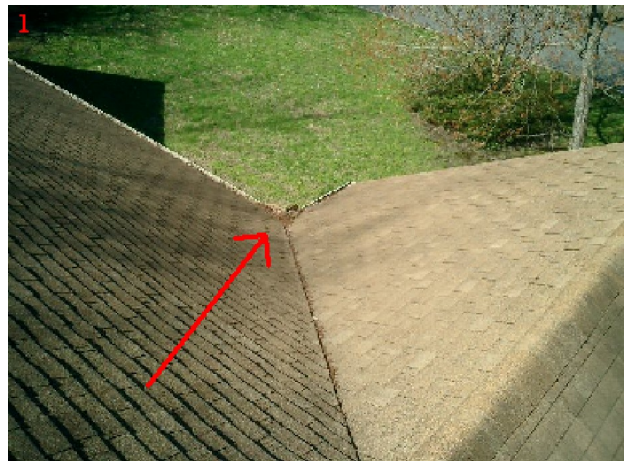
#### Maintenance Misc. Roof - -

Keep valleys clear of debris.

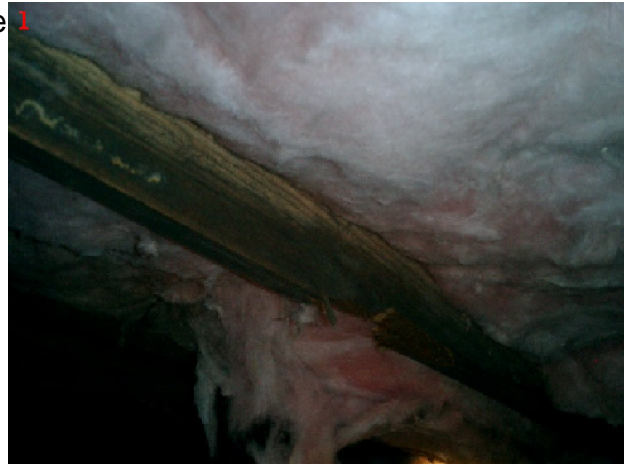
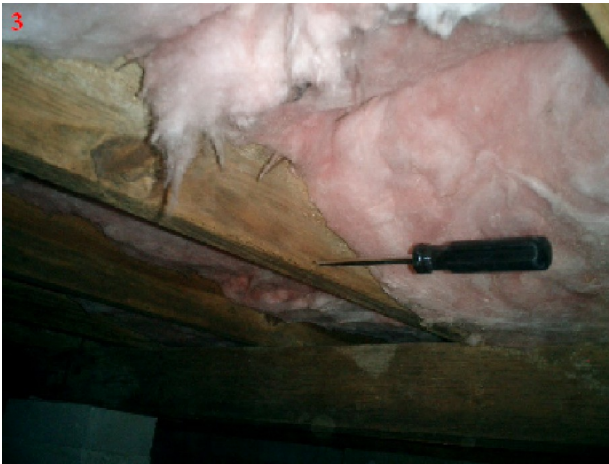
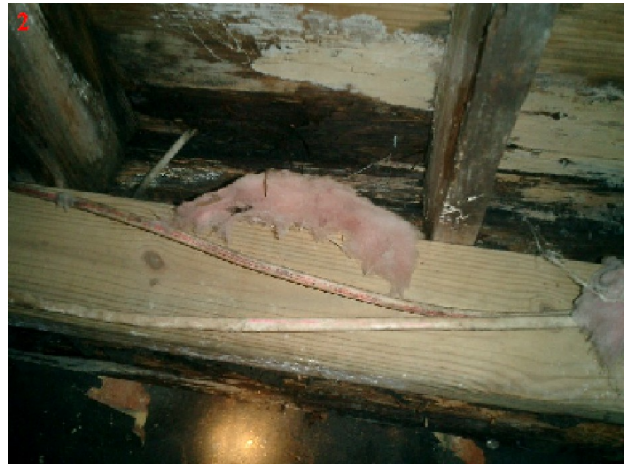
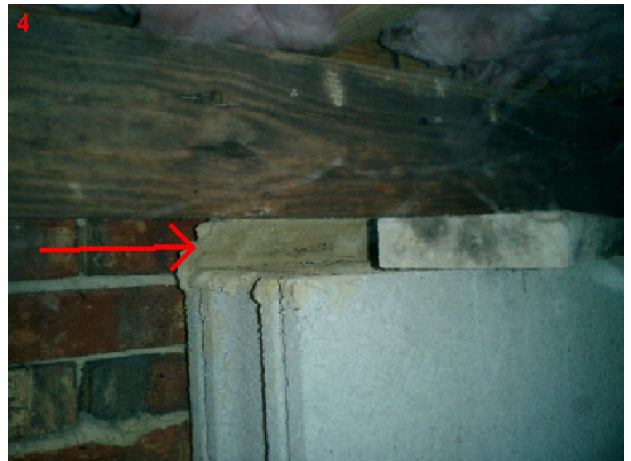
#### Foundation Inspection - Entered

Extensive moisture damage to sub structure. Some improvised repairs. Resolve moisture problem, reinforce / replace floor joists, sub floor, band board and beams as required.  
Cantilevered beam under dinette window supported by mortar. Shim up.  
Have further evaluated / corrected by a qualified structural repair contractor.
